**OTTAWA SPRAY RIG TESTS OF AN ICE PROTECTION SYSTEM
APPLIED TO THE UH-1H HELICOPTER**

Lockheed-California Company
P.O. Box 551
Burbank, Calif. 91520

November 1976

Final Report for Period January 1976 - May 1976

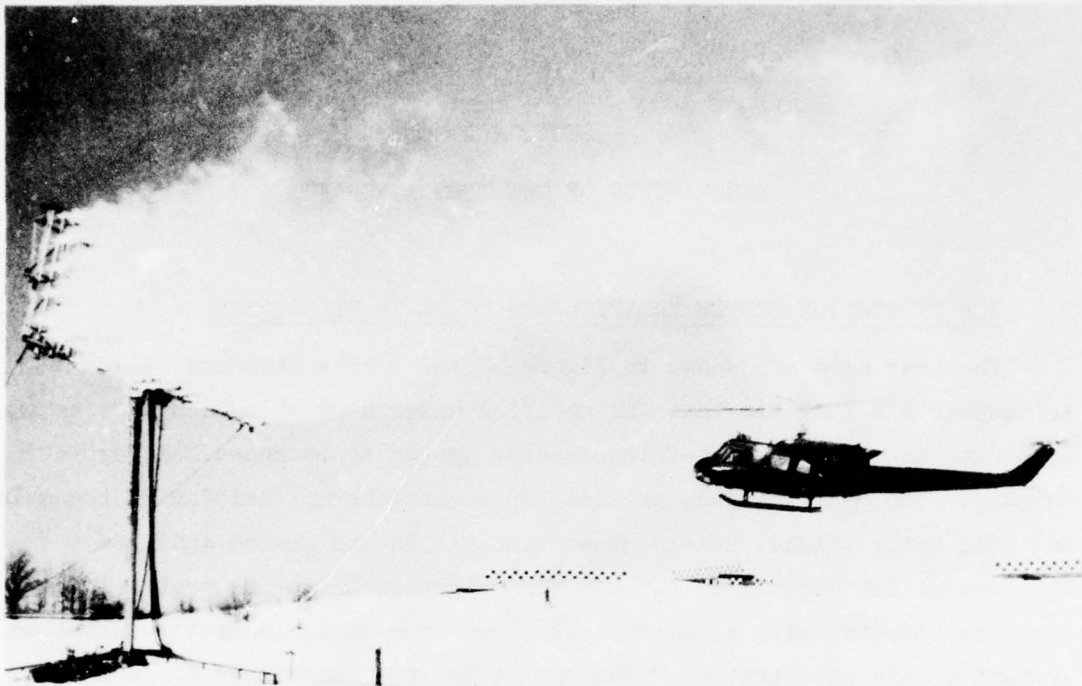
During the winter of 1975/1976, additional simulated icing flight tests were conducted in the NRC Spray Rig at Ottawa, Ontario, Canada (Figure 1). This report discusses the results of these tests. The test program was conducted during the period of 21 January 1976 to 16 March 1976.

Figure 1. Test UH-1H in the NRC Spray Rig
(10 mph Wind, - 10 °C, 0.3 g/m³)

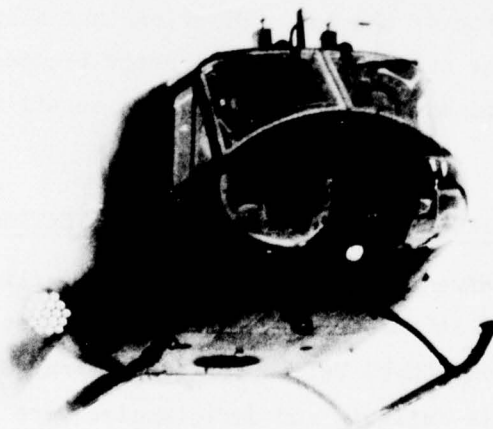
Figure 3. Rocket Pod Installation on the UH-1H

A 19-round, 2.75-inch (M-200) rocket pod was installed on the right-hand rear-mounting point location to permit evaluating icing of the pod. Figure 3 shows the pod installation during a test with individual white polyurethane foam plugs inserted into the front end of the tubes. This was one of the ice protection configurations for the rocket tubes that was tested.

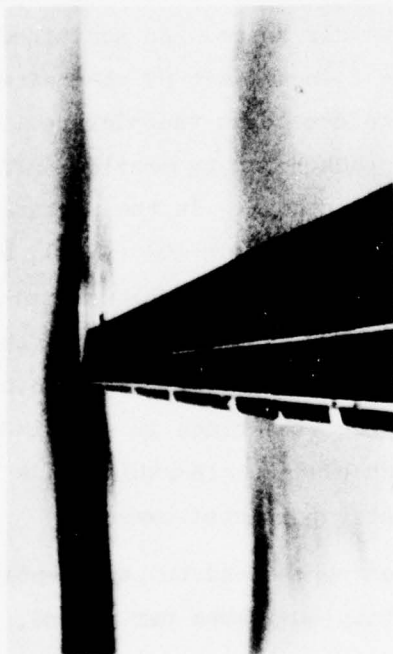
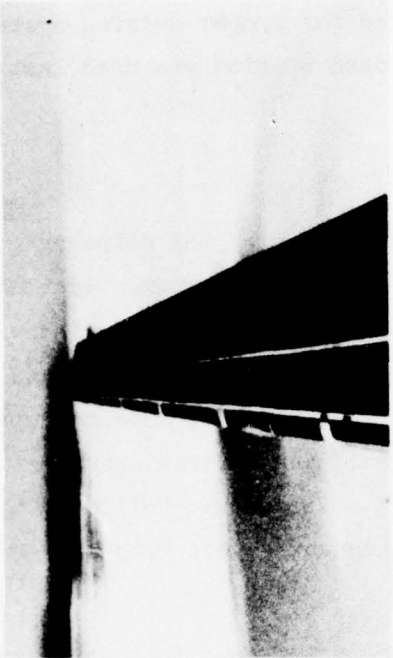
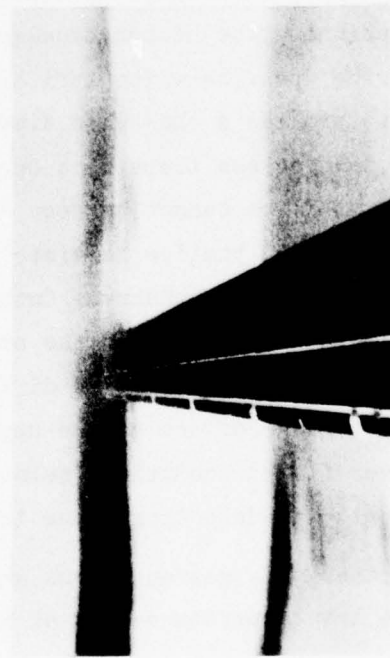
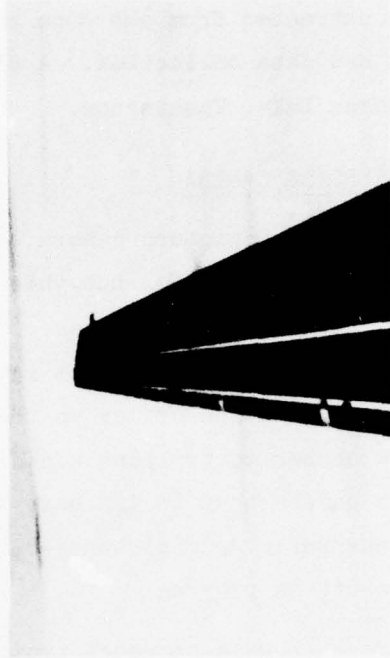
Figure 4. Blade Deicing as Photographed with Hub-Mounted 16mm Camera

Figure 4 shows a sequence typical of the best frames from a deicing cycle accomplished while operating in the spray rig just below the cloud. For photographic purposes, the blades were painted flat black with white stripes outlining the heater boundaries of the six zones. An additional 0.5-inch-wide spanwise white stripe was added 6 inches aft of the heater boundary to provide a chordwise dimensional reference in the picture. It was found that unless there is a dark enough background to provide sufficient contrast, ice cannot be seen on the leading edge. In the pictures shown in Figure 4, the ice is visible only out to Station 102 (.35R), which is the zone 4/zone 5 boundary. Outboard of this, the white background of the snow at the spray rig and the small image size in the 16mm film make the assessment of ice accretion difficult to impossible. In addition, the chordwise coverage of ice on the upper surface of the blade is a minimum in the hover flight condition (relatively high blade angle), which adds to the difficulty in detecting blade ice with the top-mounted camera.

a. Deicing Complete to Station 83 (Mid Zone 5)

b. Inboard Half of Zone 5 Shedding

c. Deicing Complete to Zone 6

d. Full Span Deicing Cycle Complete

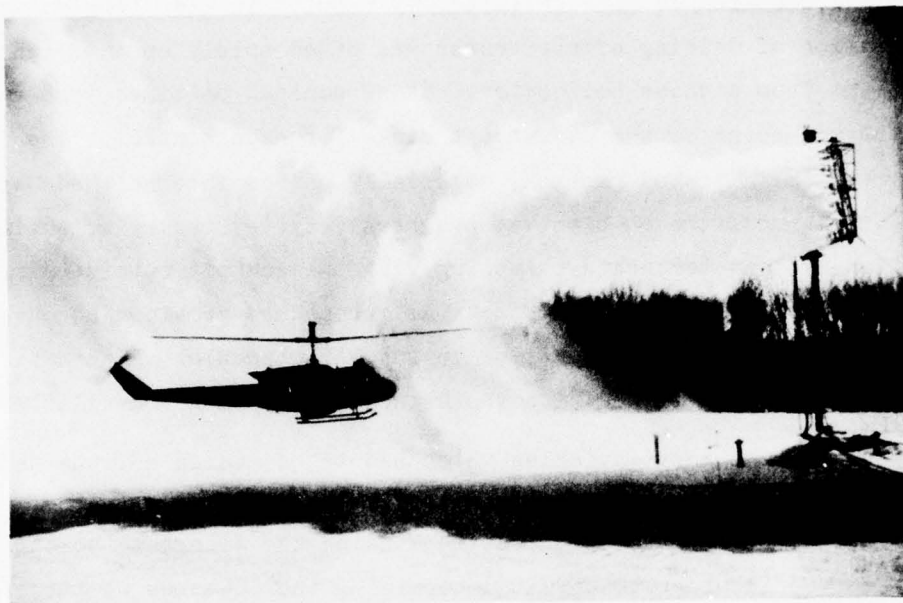
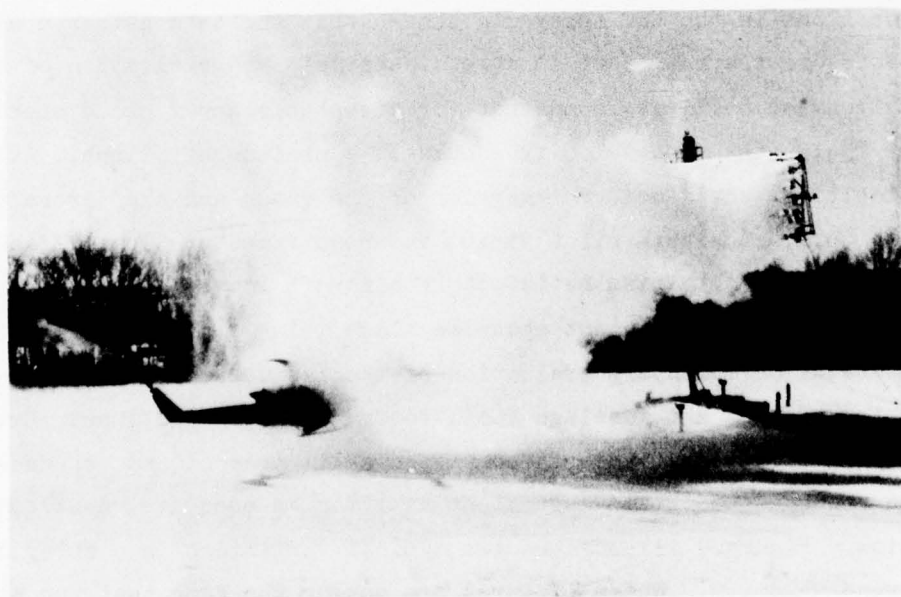
Operations in the NRC spray rig showed that the data gathered and the conclusions drawn are subject to careful analysis and evaluation of the test environment. It was found that for acceptable spray cloud operation with the UH-1H, the wind velocity should be a minimum of 10 mph. At lower wind velocities, satisfactory immersion of the rotor and the aircraft cannot be obtained within pilot visibility requirements. The difficulty in maintaining or obtaining satisfactory aircraft immersion in the spray cloud resulted in inconsistent spanwise blade icing distribution, permitted only a partial or momentary evaluation of the ice detector systems, and limited forward and aft fuselage (tail rotor) icing evaluations. Even at higher wind velocities, these factors were still present and repeat runs would be required to obtain sufficient data for an adequate quantitative evaluation. Figure 7 illustrates two typical variations in a spray cloud at low wind velocity. These pictures are during the same test run at -3.5°C and $\text{LWC} = 0.8$ gram per cubic meter in a 7-mph wind. Neither condition is considered to be good. Figure 1 illustrates a more desirable

Figure 7. Spray Rig Cloud Variations with 7 mph Wind, -3.5°C , 0.8 g/m^3
LWC

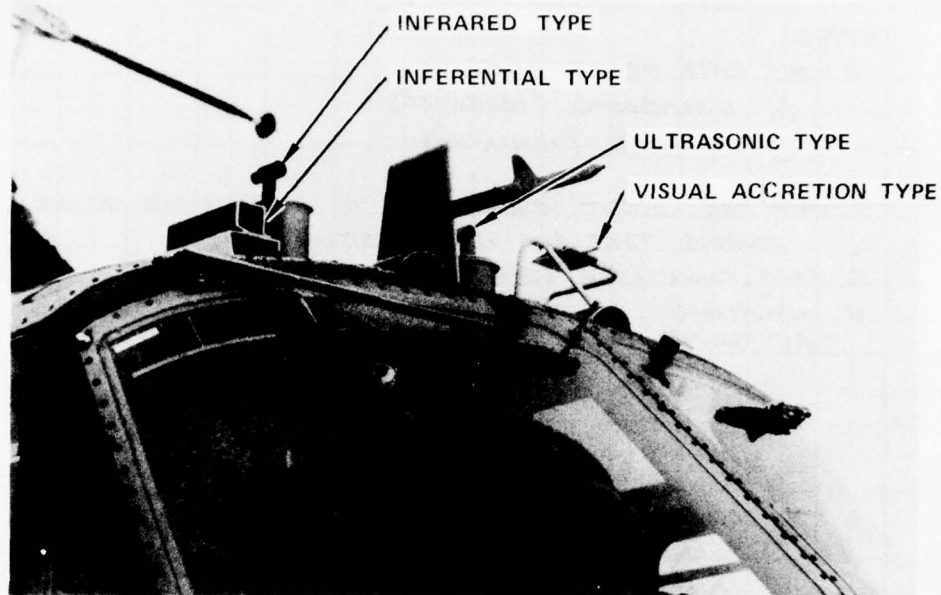
Figure 17 shows the installations of all three types after a series of cloud immersions at -12°C in a 15-mph wind.

Cockpit indications and test tape recordings showed that both detector systems functioned properly, whereas during the Moses Lake testing last year the infrared type did not indicate in flight at all. Because the nose of the aircraft could not be fully immersed in the cloud in order to permit the pilot to maintain outside visual reference, both of the rate meters usually indicated lower than the LWC setting for the cloud. Thus, a quantitative accuracy evaluation could not be made. An overall evaluation based on flight crew reported observations is shown in Figure 18. This shows that the ultrasonic type generally read a lower LWC condition than the cloud. Based on these data, the infrared type appears, in general, to correlate with the cloud LWC. Both were supplied with the same bleed airflow at approximately 40 to 45 psi and 70°C . Further evaluation on a more quantitative nature is required.

One discrepancy was noted in operation of the ultrasonic type's rate meter. It appears that the hold period of 16 to 17 seconds on the rate indication while the detector probe deiced and cooled in preparation for the next accretion period was insufficient, as the rate indication would decrease to zero periodically. This was not noted during the previous winter's

Figure 17. Ice Detector Installations on the Test Aircraft

testing and can be corrected. The amount of ice accretion between probe deice cycles was set for 0.040 inch thickness. The system can be adjusted to trip at as low as 0.020 inch thickness. This would permit deicing within the present hold time or the hold time can be increased. In order to use the ratemeter information to schedule blade heater off-time, a shorter updating time would provide greater accuracy and therefore be more desirable.

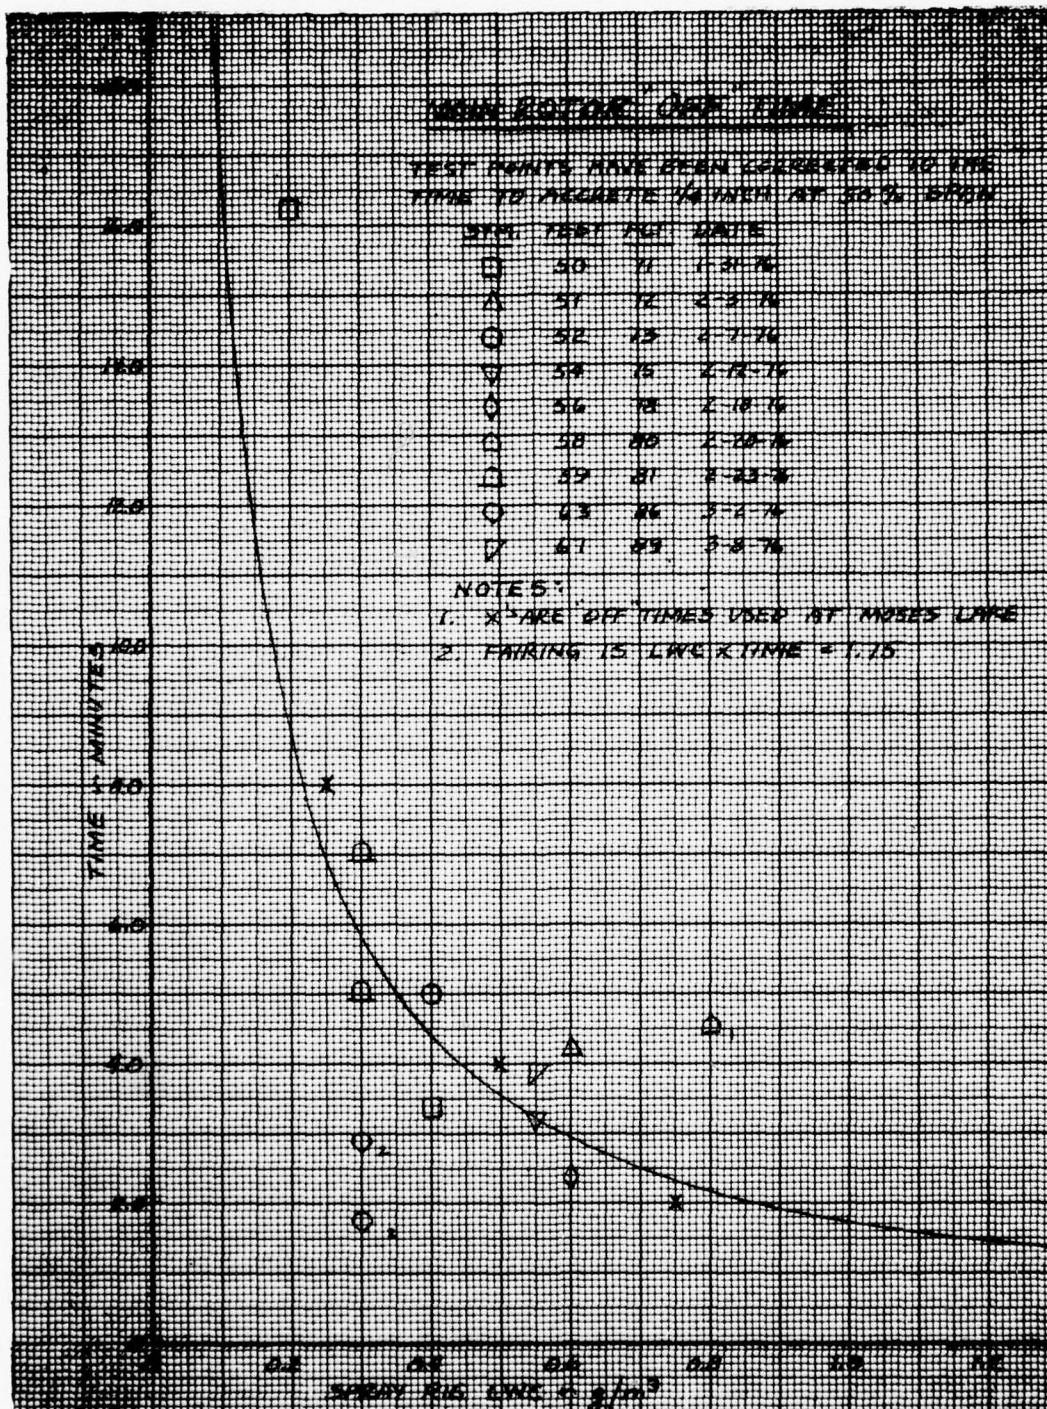
As described in Section 4.2, the initial testing at each cloud LWC consisted of runs to determine the time to accrete 0.25 inch of ice on the main rotor blades at the midspan point. The time thus determined was used as the off-time between deicing cycles when operating in the cloud for 30 minutes. Figure 19 shows the test data obtained from these ice accretion runs. All measured ice thicknesses were not the desired 0.25 inch and not always available at the midspan point because of self-shedding and nonuniform cloud immersion. Appropriate corrections were applied to the

Figure 19. Main Rotor Off-Time

measured data using the local velocity ratio to correct thickness for span location and the desired-to-measured ice thickness ratio to correct the time. The fairing shown is for a product of LWC and time (in minutes) equal to a constant of 1.75. This obviously assumes that the catch efficiency is constant and independent of temperature. Figure 19 also shows the accretion times used during the HISS test program last year. As might be expected from the many variables in the spray rig tests, considerable data scatter is apparent. An attempt was made to associate the scatter with temperature and/or wind velocity but no positive relationship could be established. The points indicated by a subscript 1 and 2 were from runs with marginally light and relatively high wind speeds, respectively. Discounting these points, the curve is a reasonable basis for use in future testing of the UH-1H aircraft. It appears to be valid for in-flight or spray rig operation.

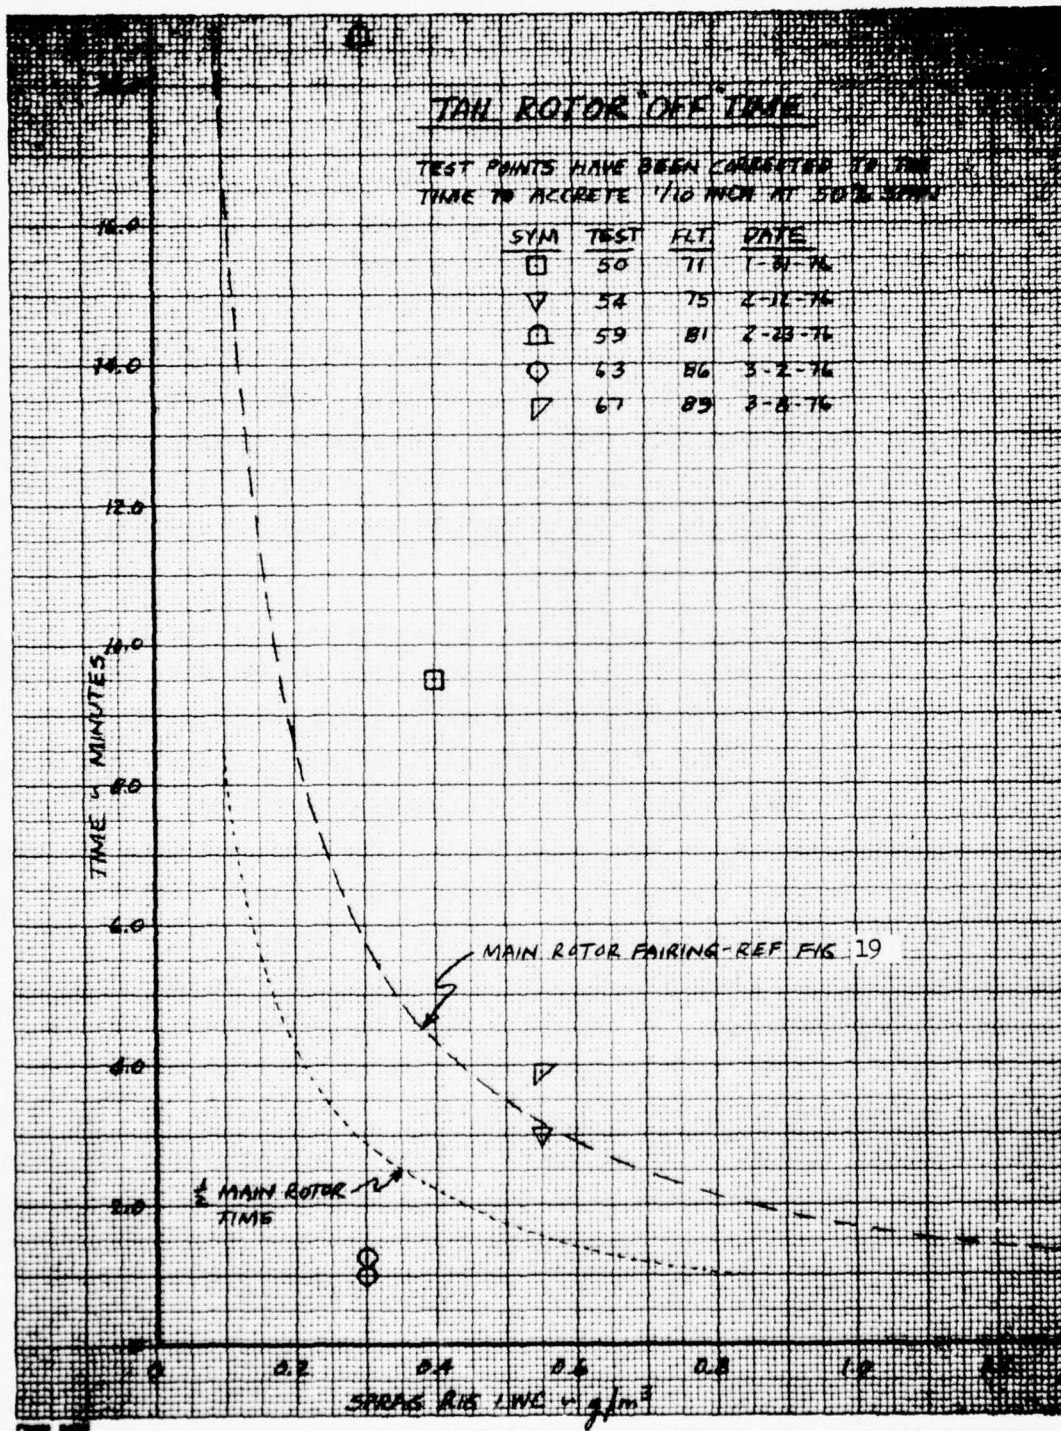
A similar evaluation of tail rotor ice accretion data was tried but there is little confidence in the indications from the results. An assumption was made that the criterion for thickness would be a scaling of the 0.25 inch on the main rotor on the basis of main to tail blade chord dimension ratio. This results in a desired thickness of one-tenth of an inch at the midspan point of the tail rotor blade. The available data for the tail rotor are shown in Figure 20. The data are extremely limited and show considerable scatter although the relative scatter is interestingly very similar to the same points for the main rotor. If the same fairing is used for the tail rotor, it indicates that the off-time for the tail rotor to accumulate 0.1 inch of ice is the same as the time for the main rotor to accumulate 0.25 inch of ice. However, on the basis that the velocity of the midspan point on the two blades is approximately the same, the tail rotor off-time should be on the order of one-half of that for the main rotor. The discrepancy is probably due to the fact that in the spray rig cloud, the tail rotor is not exposed to the same icing environment as the main rotor.

It is felt that the tail rotor data obtained in the spray rig is not representative of the hover condition because of the incomplete cloud

Figure 20. Tail Rotor Off-Time

coverage. Therefore, until more definitive data are obtained, the recommended tail rotor off-time to use is one-half of the main rotor off-time.

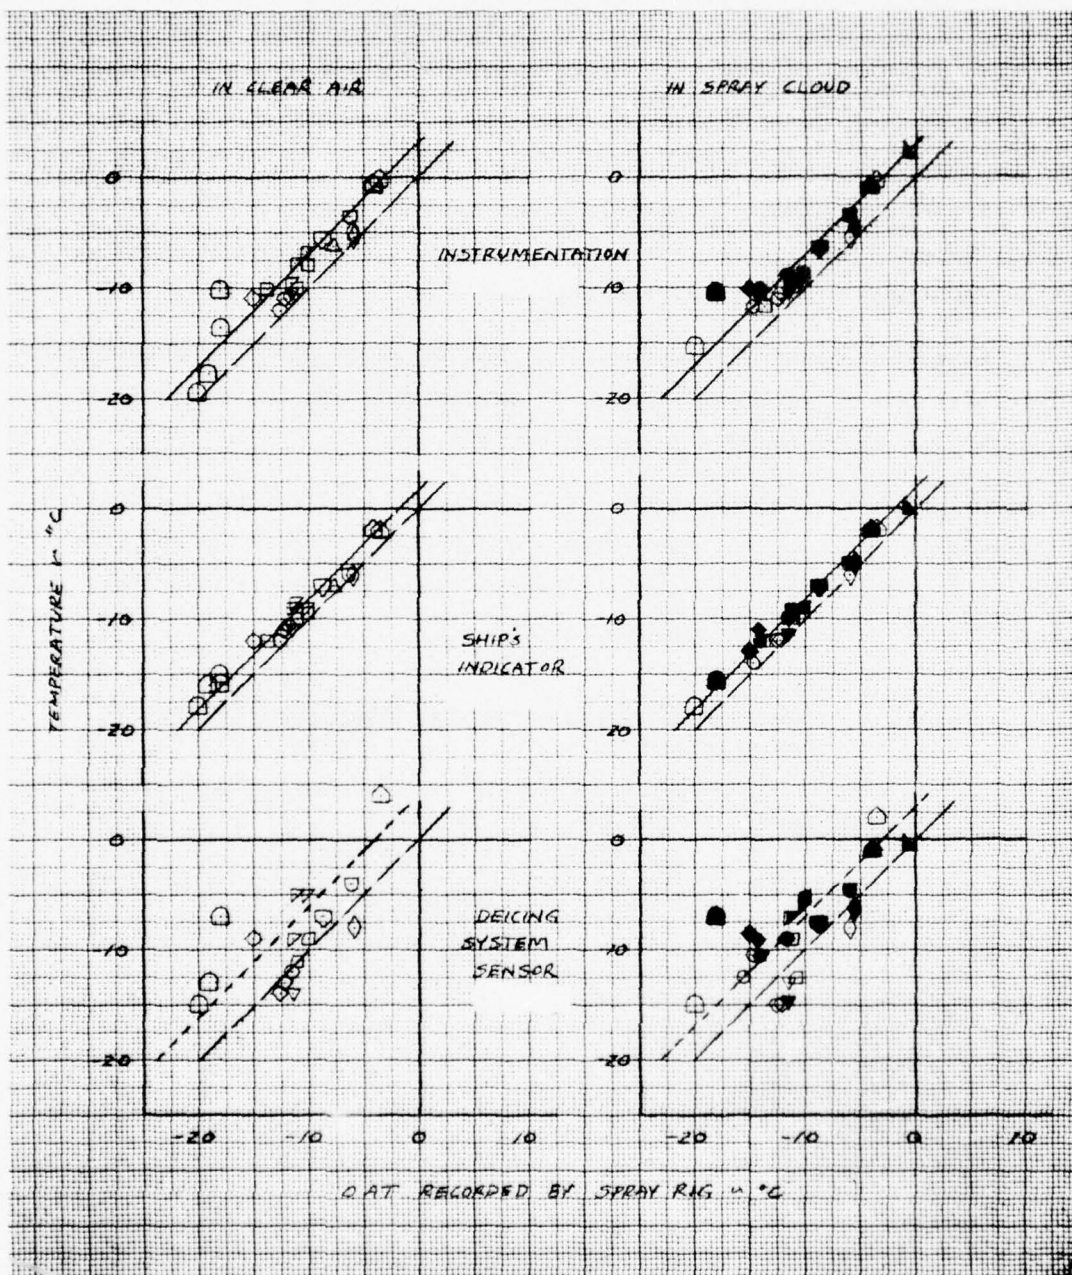
Figure 33 shows the comparison of each system with the spray rig measurement. The flight data are shown for operation in clear air and while in the spray rig icing cloud. The data show that the TEST and the SHIP OAT read approximately 2 to 3 degrees warmer than the spray rig whether in clear air or in the icing cloud. This could be due to the exhaust recirculation effects in hover or it could be that the spray rig OAT is in error. Excessive test point scatter in the readings from the SYSTEM OAT indicates a problem of unknown nature at this time, but one which makes the present system and/or location unsatisfactory for a deicing system input. Conflicting trends and comparisons have been indicated by the data obtained so far. For example, lab tests indicated a humidity and/or moisture problem in the signal conditioning in the deicing control panel. A correction was made which eliminated the sensitivity in the lab; however, flight data still indicated approximately a 5-degree error. A biasing resistor was added to the circuit prior to the results shown in Figure 33 but a 5-degree average error is still indicated in hover. Limited comparison with a mercury thermometer showed good agreement under static conditions. Data in climb showed exact correlation with the TEST OAT but increasing error when compared to SHIP OAT. In level flight, the SYSTEM OAT showed decreasing temperature with increase in air speed whereas the TEST OAT showed the proper change. A more detailed investigation of the system calibration and possible signal conditioning errors should be accomplished prior to use as a SYSTEM OAT input. It is possible that the sensor location under the nose is unsatisfactory. Since there are two sensors presently installed, one could be relocated and evaluated in future testing.

Figure 33. Comparison of OAT Measurements

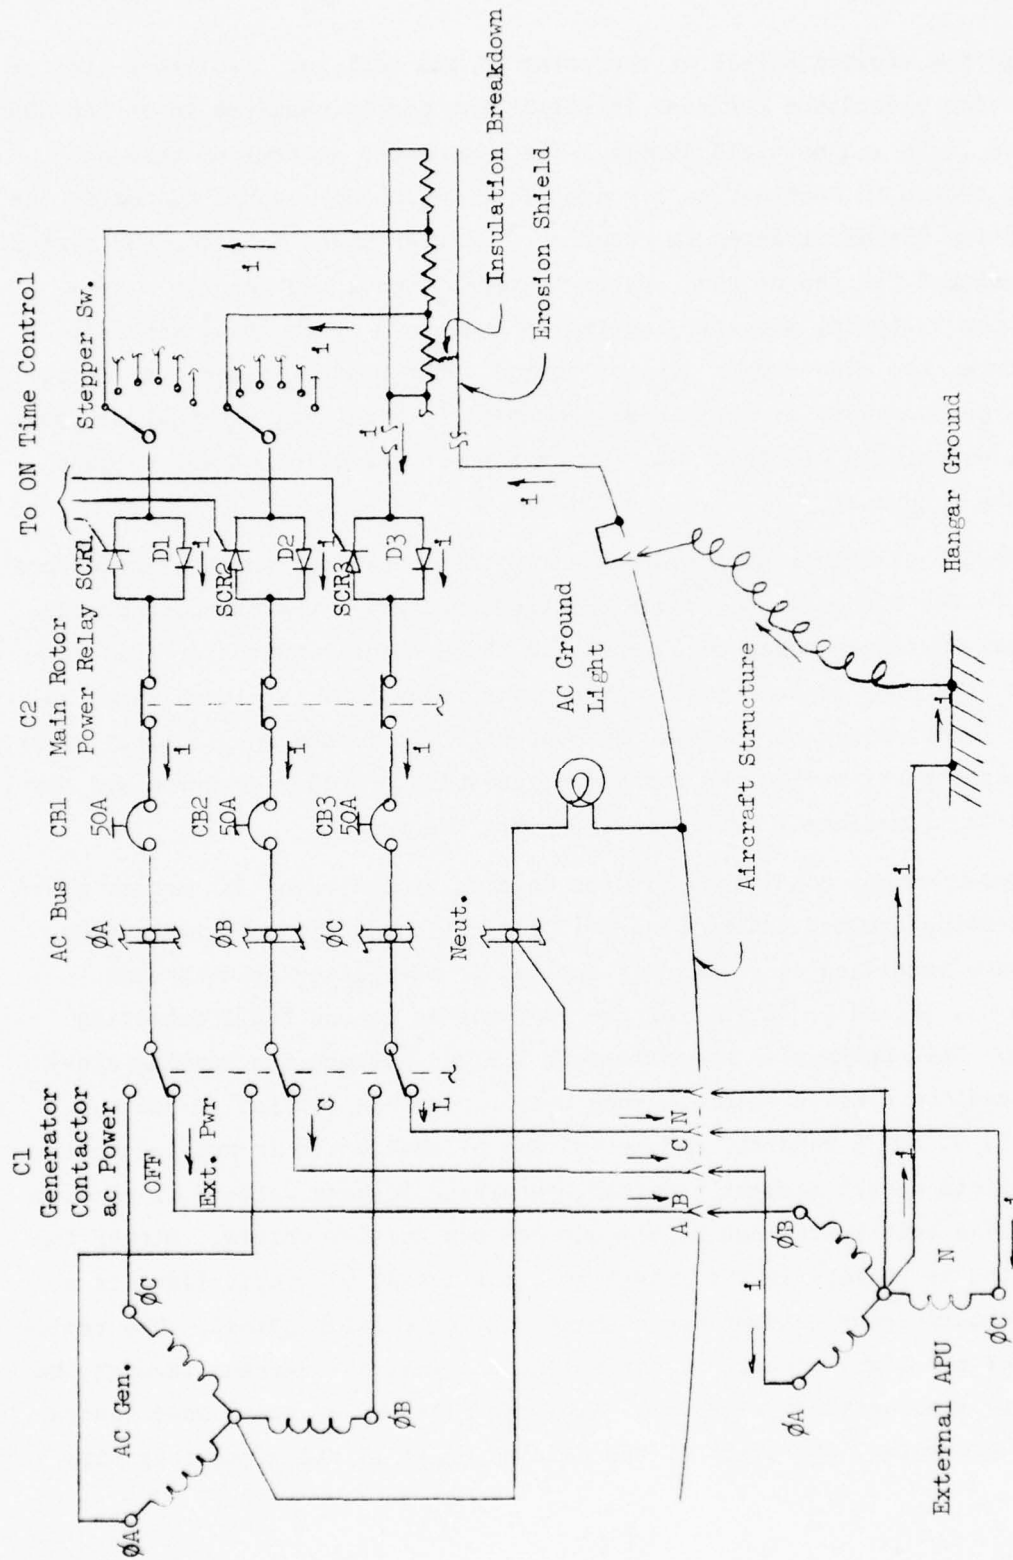
Figure 34 illustrates schematically the conditions which existed when the hole was burned in the blade. External ac power was supplied by the external auxiliary power unit (APU), and the generator contactor (C1) connected it to the ac bus. Main rotor power relay (C2) is closed when the master power switch on the deicing controller is turned on. Shortly after the master power switch was turned on, an audible arcing occurred and the switch was immediately turned off, stopping the arcing.

Under normal conditions between deicing cycles when with heater power is not being applied to the blades (SCR's not conducting), three-phase half-wave rectified dc voltage is applied to the heater grid through diodes D1, D2 and D3 as part of the system's ac ground fault detection system. This voltage is approximately 165 Vdc between the heating elements and the erosion shield. When heater power is applied to deice, SCR's 1, 2, and 3 conduct, and ac voltage of each phase is applied to the appropriate heater element terminal, resulting in peak voltage of as much as 165 Vac between the heater element and the erosion shield. Either the dc or the ac voltage is sufficient to light the AC GND fault light if a short should occur between the element and the erosion shield. The resistance of the light circuit is sufficient to limit the current through the short to a nondestructive level. With the floating or ungrounded neutral at the generator, operation of the deicing cycle is still possible with

Figure 34. Schematic Showing External AC Power Connected to the Ship and Current Flow through an Insulation Breakdown

In the case at Ottawa with an external APU supplying power, the current limiting AC GND light was shunted by the APU's neutral ground and the normal grounding cable attached to the aircraft in the hangar. In this configuration, when the insulation breakdown occurred, current through the fault was limited only by the impedances of the heating elements, phase power wires, diodes, and ground straps. As shown by the arrows in Figure 34, half-wave rectified fault current flowed from the cart neutral to hangar ground, through the aircraft ground strap to aircraft structure, through the aircraft structure to the erosion shield, through the breakdown to the heater elements, and back through the diodes D1, D2, and D3 and the system to the ground power cart phase terminals. Fault current was interrupted by opening of the main rotor power relay (C2) when the master power switch was turned off by the operator. Fault current flowed for approximately 2 seconds and was manually interrupted before the circuit breakers tripped.

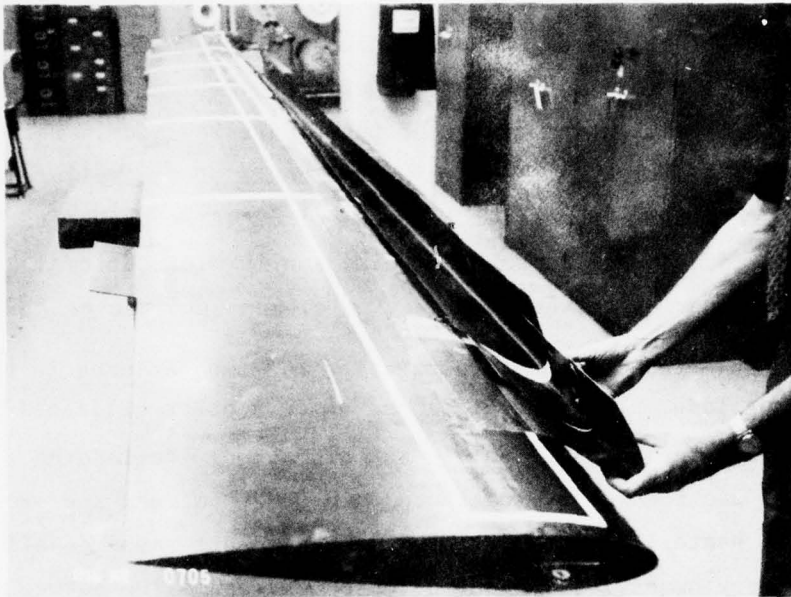
Figure 36. Blade S/N A2-25934 with Erosion Shield Removed

The blade selected for the investigation had two failures in the outer portion of the blade. The other failure was in another blade near the inboard end of the steel erosion shield but also along the leading edge. The erosion shield was removed by forcing a thin wedge between the erosion shield and the heater element. The shield peeled off rather easily under a progressive prying action and separated on the bond line between it and the heater outboard insulation material. Figures 36 through 39 show the blade with the shield removed and some of the overall condition underneath. Detailed inspection of the heater installation revealed the following:

- There was nothing obvious that would explain the exact failure mode.
- There were two or three places along the leading edge where the heater and its insulating material did not adhere to the erosion shield. This condition was present in the area where the two failures were experienced.

- There were void areas in the bonding adhesive between the erosion shield/heater element/backing material assembly and the basic blade contour. This condition was aft of the leading edge.

- There was an apparent difference in the insulating glass cloth used inboard of Station 176.6, the zone 2 and 3 boundary, from that used outboard. The cloth inboard appeared to be dry and devoid of any impregnating resin. It is not known whether all the blades were like this, as only one blade was disassembled.

- Although the exact failure mode is not obvious, the general condition of incomplete bonding contact and/or adhesion along the leading-edge area suggests potential hot spots that could eventually result in a breakdown through the insulation.
- The "dry" condition of the insulating material found under the inboard half of the steel erosion shield would easily absorb and conduct moisture if the installation were not moistureproof. This could explain the reduction in dielectric strength recorded in tests of this blade both at Moses Lake and Ottawa.

- The sealing around the edges of the shield installation from possible moisture ingress to the insulating material needs to be improved.

- The main rotor blade heater installation has a problem near the leading edge that resulted in electrical short failures after 40 to 50 flight hours. It appears from a blade teardown investigation that getting a better fit of the mating components (erosion shield-insulation-heater element-blade contour) during the manufacture and possibility increasing the thickness of the insulation will eliminate the problem.

- Changes in the main rotor blade heater installation to eliminate the deficiencies that have been identified should be incorporated in the blades prior to further testing.

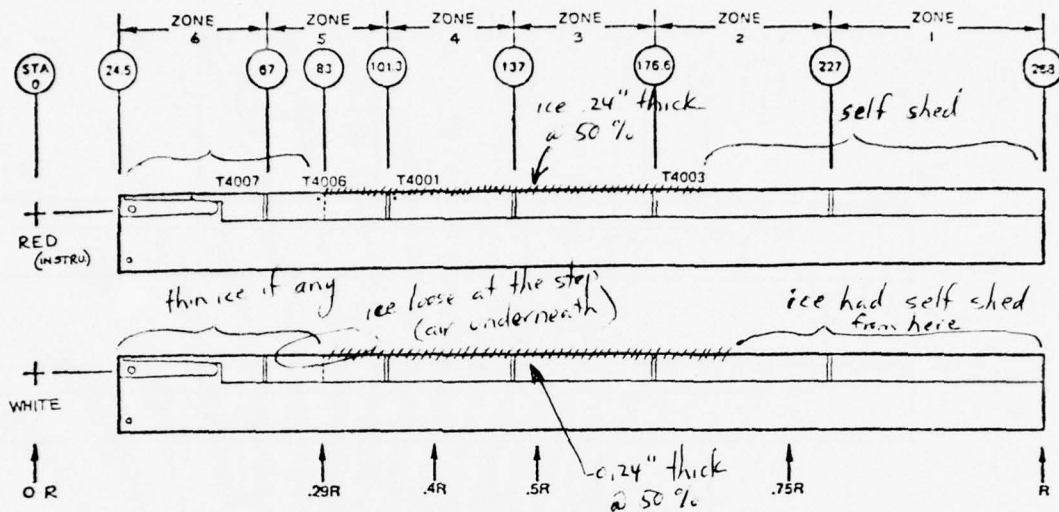
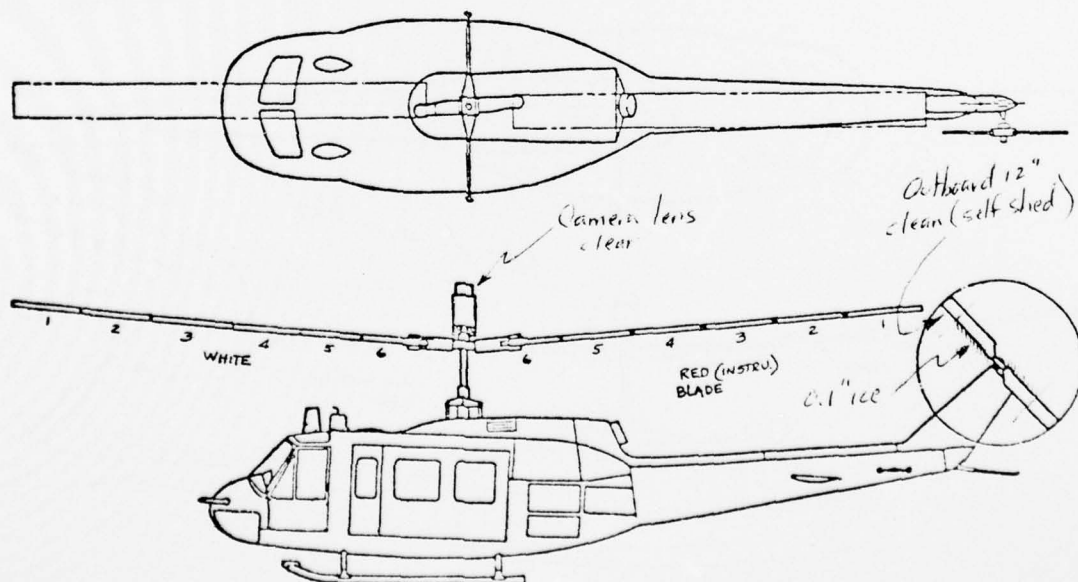
Figure 40. Typical Post-Icing Test Visual Observations Data Sheet - After Ice Accretion

TEST 54
 FLIGHT 75
 DATE 2/12/76
 SHEET 1 OF 3
 OBSERVER Colton

AFTER RUN 1
 TIME 1330
 OAT -11°C
 LWC 0.6 g/m³
 RUN DURATION 3 min

INSPECTION MADE:
☒ AFTER ICE ACRETION
☐ AFTER SINGLE DEICING
☐ AFTER MULTIPLE DEICING
☐ OTHER _____

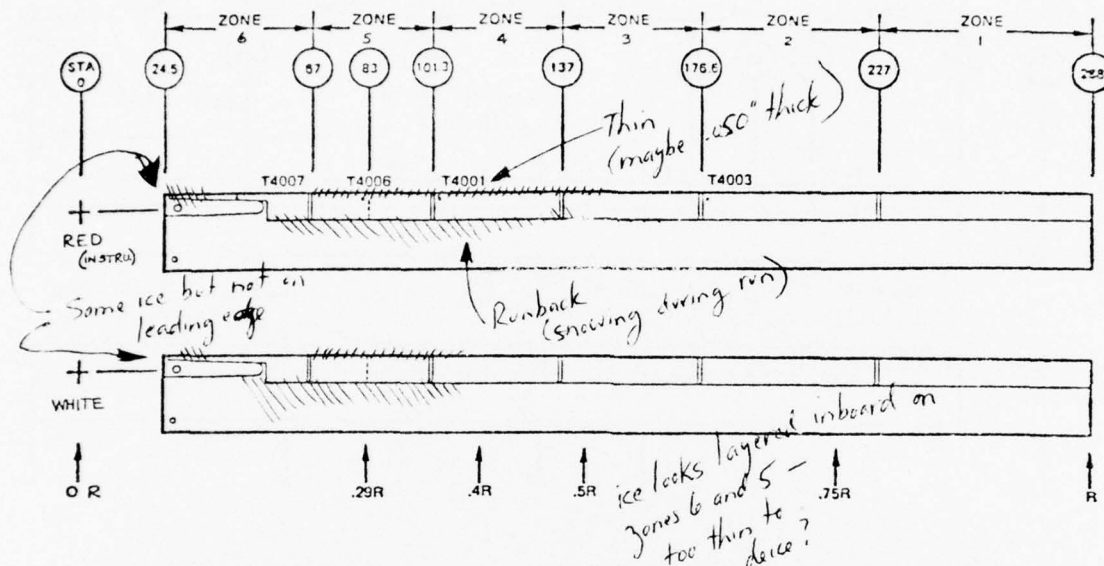
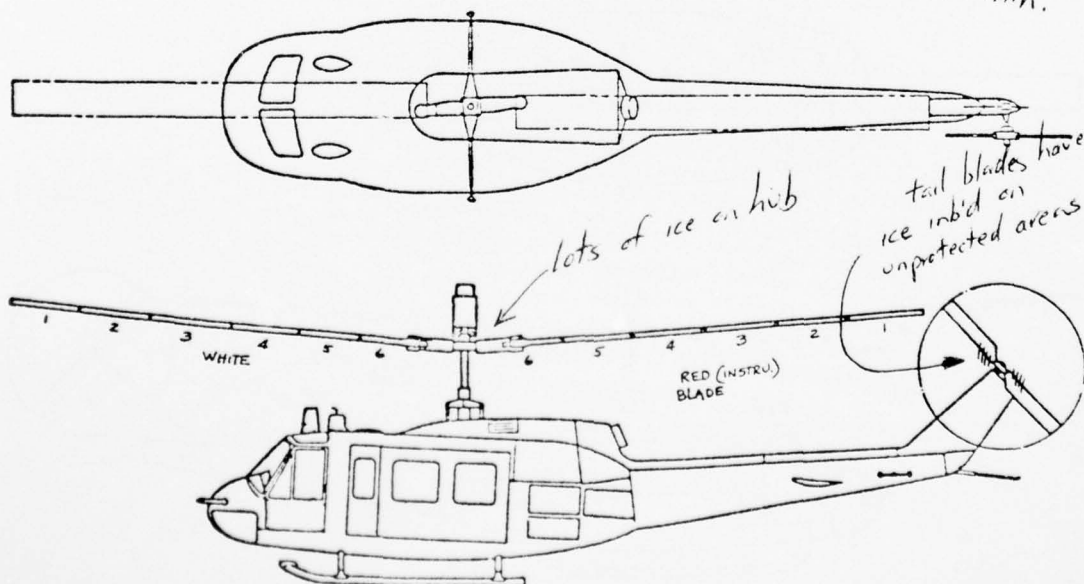
Figure 41. Typical Post-Icing Test Visual Observations Data Sheet - After Blade Deicing

TEST 54
 FLIGHT 75
 DATE 2/12/76
 SHEET 3 OF 3
 OBSERVER Cotton

AFTER RUN 2
 TIME 1430
 OAT -11°C
 LWC 0.6 g/m³
 RUN DURATION 23 min

INSPECTION MADE:
☐ AFTER ICE ACRETION
☐ AFTER SINGLE DEICING
☒ AFTER MULTIPLE DEICING
☐ OTHER _____

each 3 min.
